## 1. ECD V3.0

### 1.1 NEW CC TECHNOLOGY

This ECD has been built incorporating the last technology about the Control coils and Mobius ring.

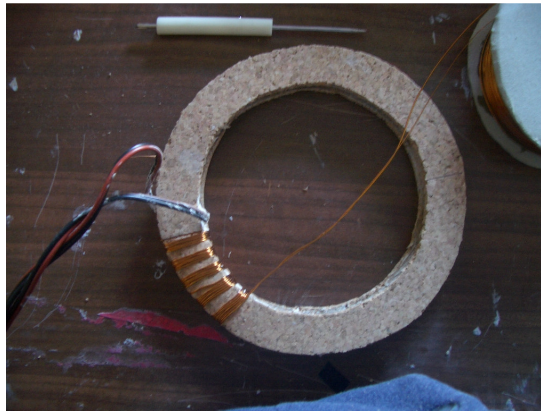
In particular the 3 Control Coils are now wounded using 4 segment and 4 layers as in following figure where you see just a single layer 5 segment coil on the annular cork support containing inside the 6" Mobius (you can see the two –two-wire lamp-cord protruding outside from left).

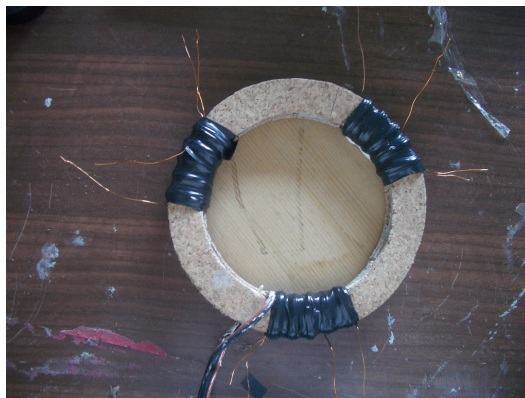
At the end you obtain 3 CCs spaced by 120 degrees like in following figure

Note: Taking as a start point the Mobius output leads, the CCs are placed in a CCW way.

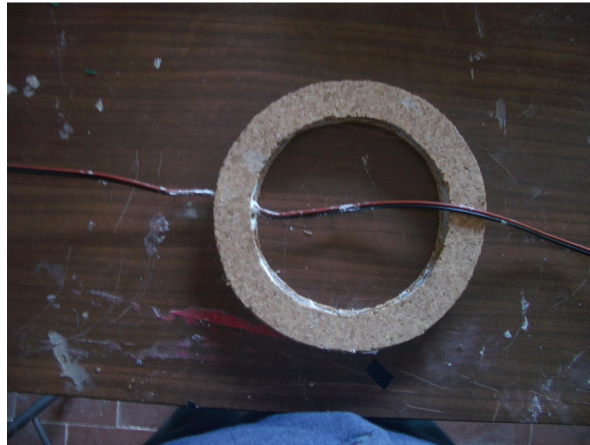
The new collector this time is not one turn but 5 turns of lamp-cord wire. The reasonn behind that kind of choose is to enhance the difference with the smaller loop as the smaller loop is there just to 'create' a difference and so a bigger potential gradient. The wire is wounded like a pancake coil in the sense that the turns are coiled horizontally and are glued onto an annular Cork support (both lower and upper) as in following figure.

The protruding wires are the coil start/end. The cork material function is to allow for coil vibration.

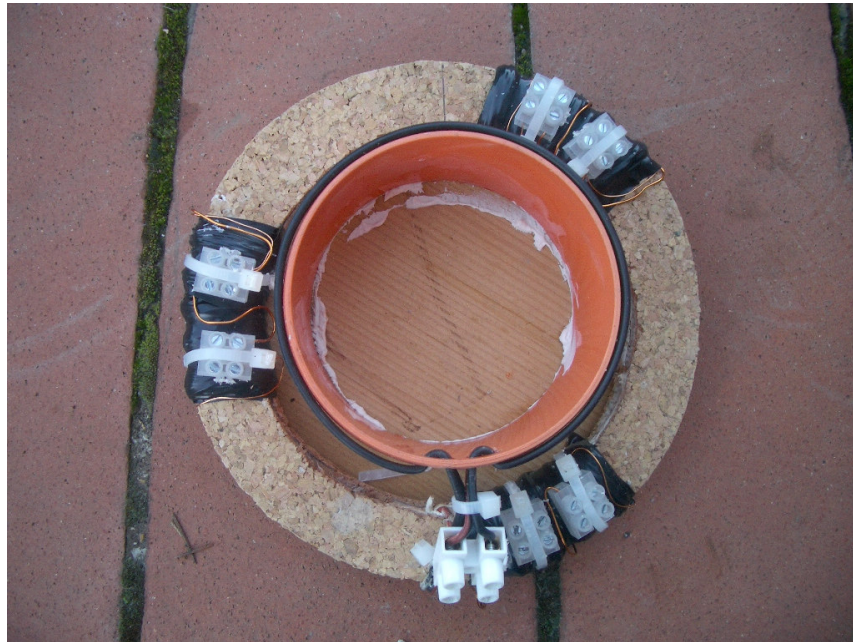
Final assembled ECD is like this:

You can see that the smaller loop is supported by a PVC tube in order to get it fixed at 44mm. of highness respect to the bigger loop inside the cork. On each CC there is provision for connecting the coils wires.
