1.1.1 Disconnecting CC coil

Disconnecting Secondary coils

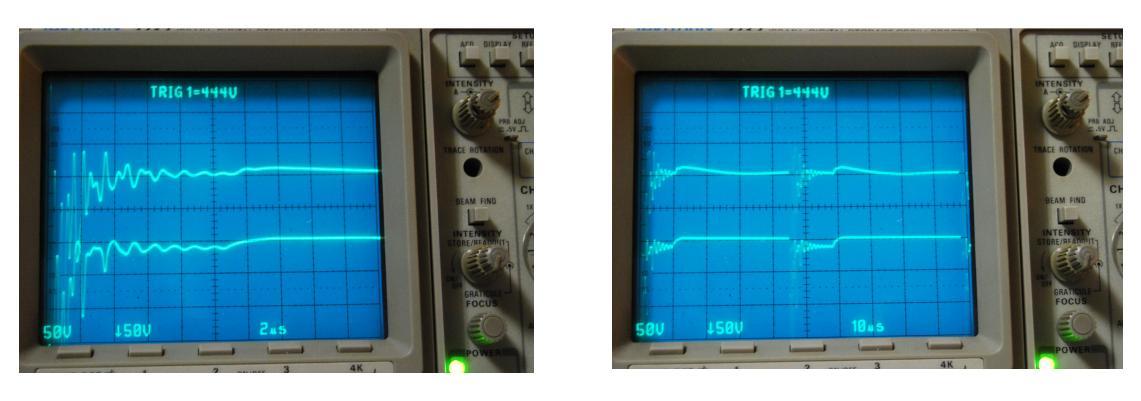
Using that setup a series of test has been run in order to ascertain what happen while disconnecting CC secondary windings. To better view the difference a preliminary setup has been run with the following waveforms (0 level is 1 div up and 1 div down).

Lamp is normally connected &lighted.

Then I disconnected all the series connected CC's secondary and of course the lamp does not light but the ECD is still operating with +850V peak on Zero and -650V on Phase: this of course does confirm that is the primary that generate said waveforms.

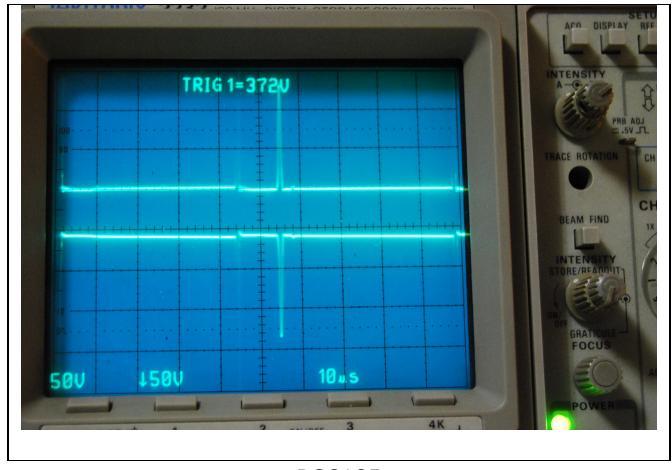
DSC105

What happen is now that the peak's amplitudes are much less: within 150V and all the ringing effects disappear.

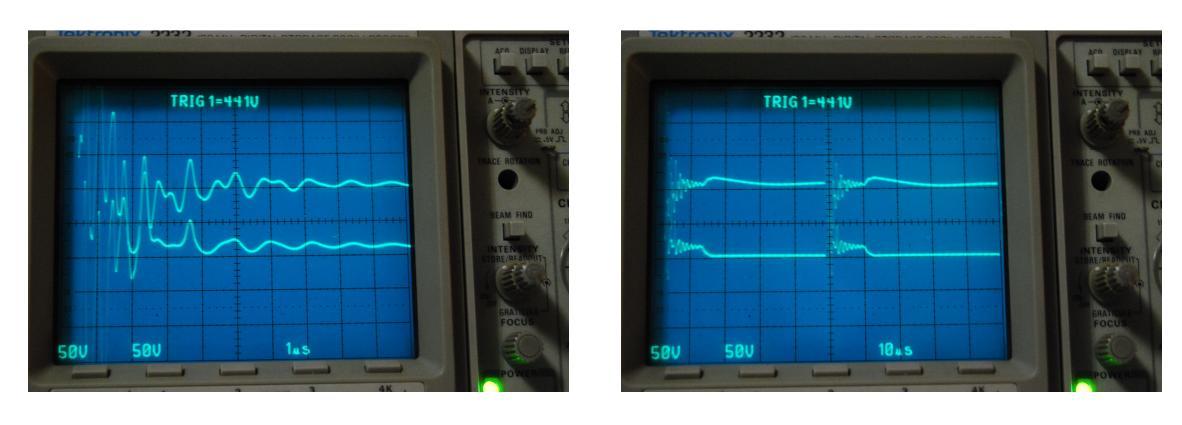
DSC108

After reconnecting both primary and secondary I disconnected the small Mobius loop (on one side)

You see that the operations are almost equal: so no differences.

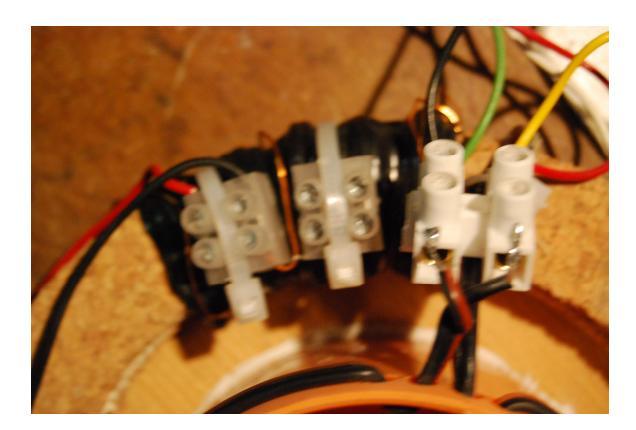
DSC110

In this case both the small Mobius wires connecting to the big Mobius loop are disconnected as you can see in following pic.

I obtained exactly the same output.

Leaving or connecting one side (both wire) of the small Mobius don't seem to add significant effects. This sounds indeed weird. At the moment I do not have a sustainable explication as according to par **Error! Reference source not found.** its behavior should be completely reactive!

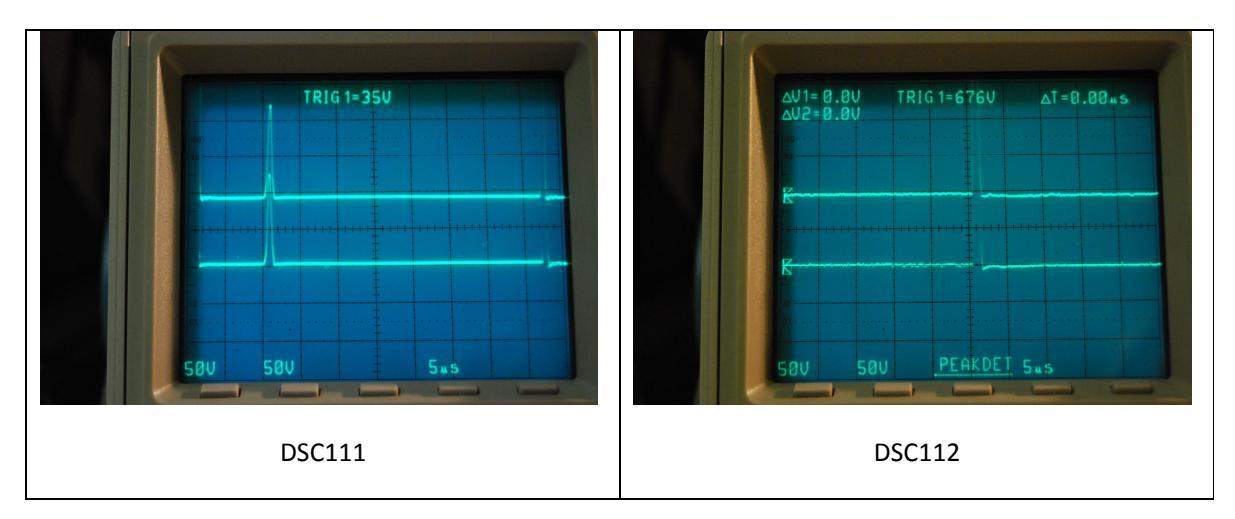
Using said condition I disconnected the secondary obtaining following pic.
